ONEIDA NATION OF NEW YORK TRIP REPORT

Assessment of Mold and Moisture Conditions

January 21, 2003

U.S. Department of Housing & Urban Development
Office of Native American Programs

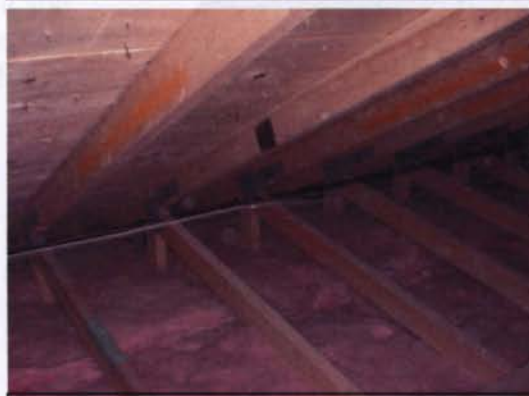
Attics are insulated to R38 with fiberglass batt insulation. Roofs are constructed with raised-heel trusses to allow full depth insulation over the top plates (Figure 2). Roof ventilation is provided by a combination of soffit and ridge vents.

Figure 2 - Raised-heel truss allows full depth insulation over top plates

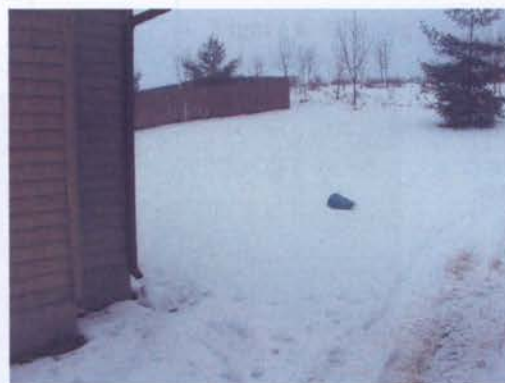
Most of the twenty homes in the development appear to be built on the low part of the site and are experiencing water problems in the basements (Figure 3). Flooding has been an issue in some of the homes. Drainage immediately adjacent to the homes was flat.

Figure 3 - House located near base of hill.

Current remediation efforts should focus on improving site drainage conditions and solving the basement moisture problems. One solution, trenching around the home to install a new foundation system, presents an opportunity to add exterior foundation wall insulation if not already present. It is recommended that 1" (R5) to 2" (R10) of extruded polystyrene insulation be added before the foundation wall drainage system is added. Installing exterior foundation wall insulation has two benefits:

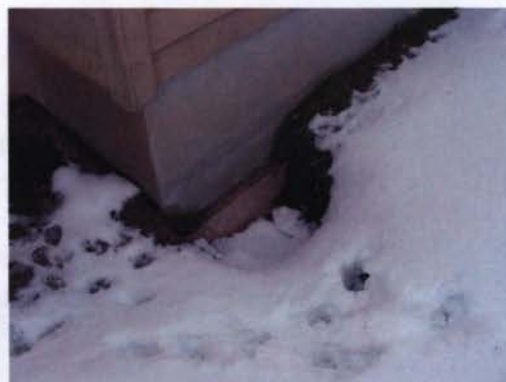
The team found holes and dips caused by settling adjacent to the foundation at 2211 Sweetgrass Lane (Figure 4). Ponds from snowmelt were found behind the home at 3302 Runner's Road.

Figure 4 - Settling against foundation – note presence of exterior basement wall insulation

Holes and dips adjacent to foundations should be filled-in to divert water away from the foundation where foundation wall remediation work will not be done. It is best to do this correction after backfill has had time to settle.

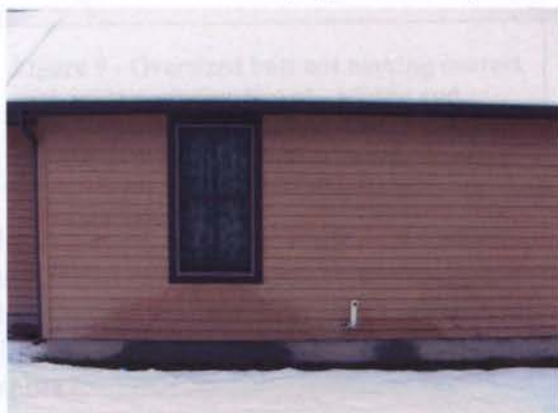
As a result of site drainage, backsplash (Figure 5) and rainwater/snowmelt management problems, mold and moisture problems were being experienced in the basements. Some foundation walls were wet and mold was found on other basement walls (Figures 7 & 8).

Figure 5 - Back splash onto siding from melting snow on roof

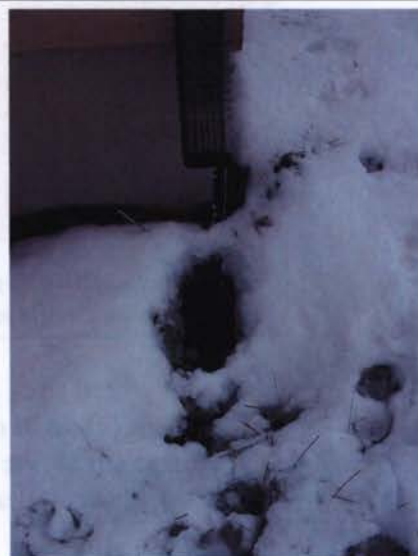
All of the homes had gutter systems that appeared to be in good shape. Flip-up leaders were found in some locations. The leaders were made from a light gauge plastic. Some of the leaders were broken or cracked that may have resulted from being stepped on. Some leaders and splash blocks were missing (Figure 6).

Figure 6 - Missing leader and splash block

The gutter systems on the inspected homes were in good shape. Where downspouts will not be tied into the new foundation drainage system, damaged flip-up leaders should be replaced (perhaps with a more durable type) or splash-blocks added where missing.

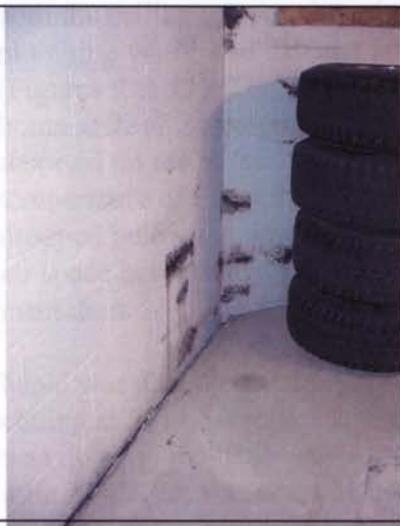
Figure 7 - Mold growing on basement wall

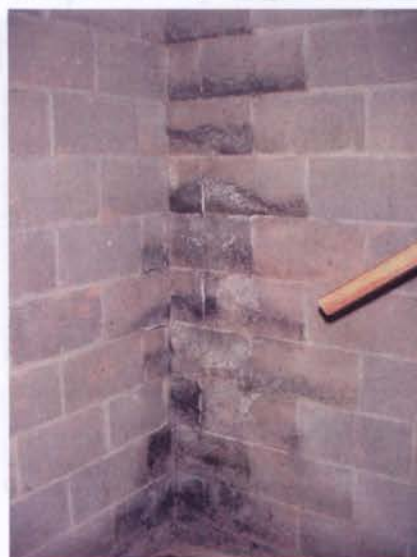
Figure 8 - Mold on basement wall

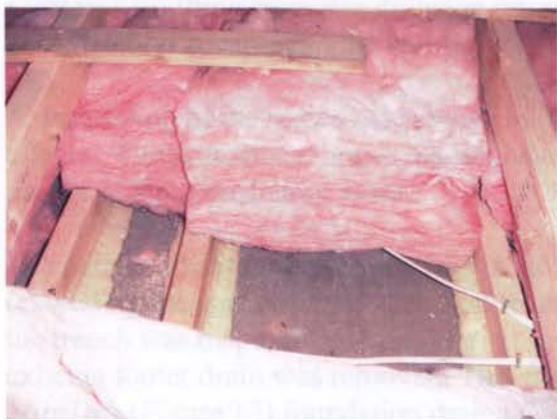
Figure 9 - Oversized batt not making contact with ceiling gypsum board - wiring and plumbing vent pipes also restrict insulation contact with ceiling gypsum board

Batts were oversized for the joist cavities and were not pushed-down to make contact with the ceiling gypsum board. The problem was compounded by the presence of wiring plumbing vents, and exhaust fan ducts (Figures 9 & 11). This was the case in the home at 2212 Sweetgrass, where mold was reported on the bathroom ceiling. The temperature of the ceiling drywall may have dropped below the dew point because of the air space between the ceiling and the insulation.

Attic insulation should be inspected where ceiling mold or moisture conditions are reported to ensure that the insulation is in contact with the ceiling gypsum board and that

the insulation is continuous without voids or gaps. Consideration should be given to replacing the batt insulation with blown insulation where this condition is prevalent or when rehab work permits it.

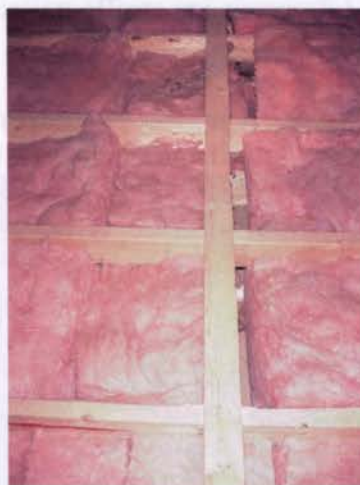
Figure 10 - Gaps between pieces of batt insulation

Insulation should be installed as a continuous blanket. At eaves, gaps below the insulation can lead to lower thermal performance. Gaps between batts (Figure 10) can lead to cold spots, made worse if the insulation is suspended up above the ceiling drywall (Figure 9). The inspected homes had discoloration or mold growth possibly from cold spots.

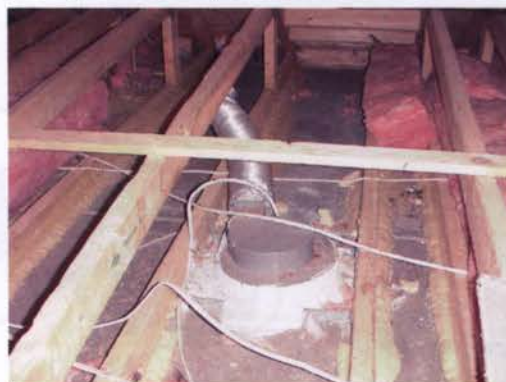
Mold was also reported on the bathroom ceiling at 2211 Sweetgrass. Maintenance work was done on the bathroom exhaust fan, but the attic insulation was not replaced following this

Figure 11 - Insulation not replaced following maintenance work completion

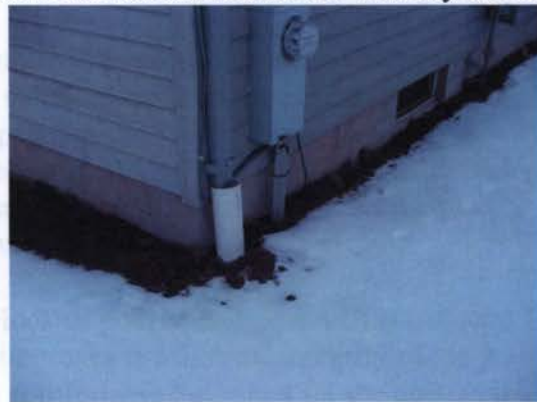
Figure 12 - Downspout tied to new foundation drain

The perimeter of the house was excavated (excluding the garage perimeter). Soil from the trench was disposed off-site. The existing footer drain was removed. The *MiraDri* (Figure 13) foundation drainage system and a new 4" diameter perforated PVC foundation drain were installed. Downspouts were tied to the new footer drain (Figure 12). The footer drain was extended to daylight. The trench around the footing and foundation drain was backfilled with stone. The trench adjacent to the foundation wall was

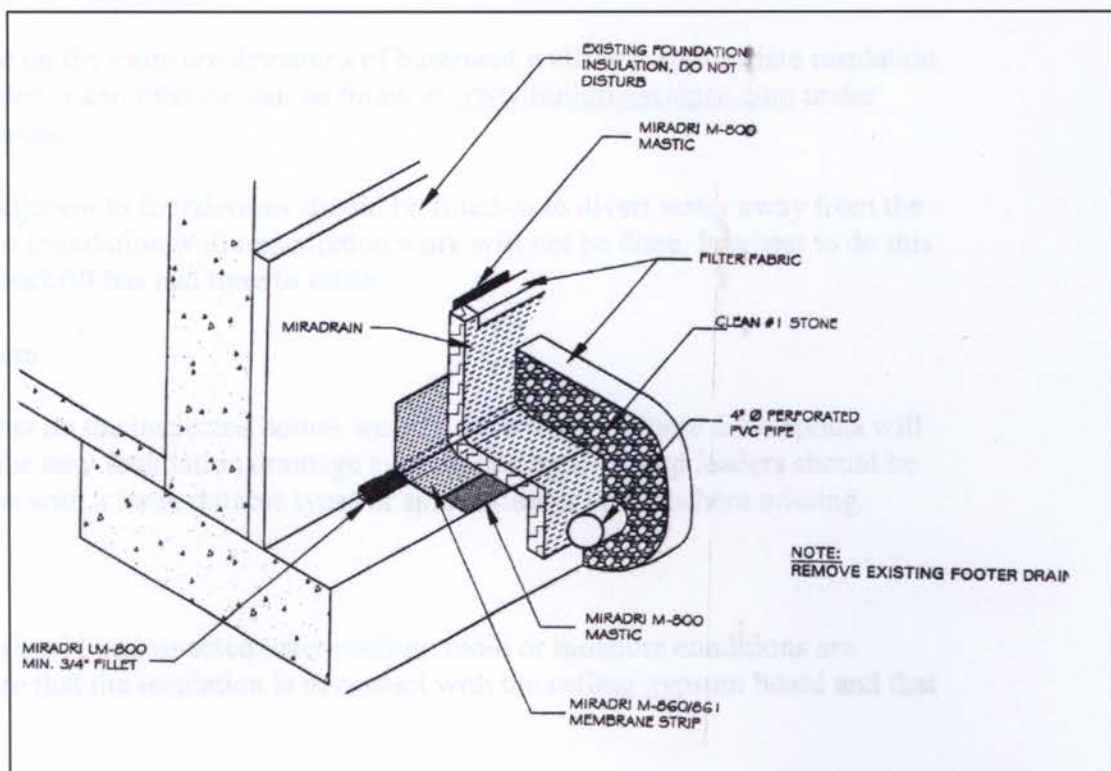
Figure 13 - Foundation remediation system

filled with sand. Topsoil was used to provide positive drainage away from the home. Mold was removed from the interior of the home and surfaces were painted. A higher capacity bathroom exhaust fan was also installed. Total remediation cost was \$25,000.

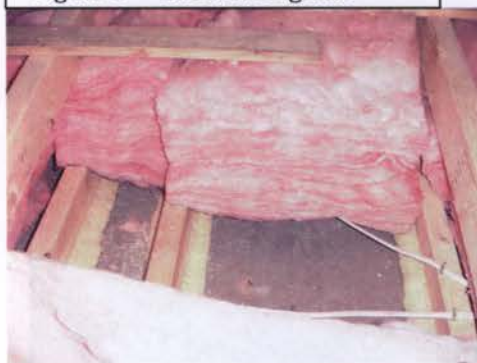
Attic: The attic was insulated with R38 fiberglass batts. The insulation was not in contact with the ceiling drywall (Figure 2), especially over the bathroom ceiling where mold was reported. Some mold was spotted on the roof sheathing near the bathroom exhaust fan termination point.

Figure 2 - Insulation not in contact with ceiling gypsum board

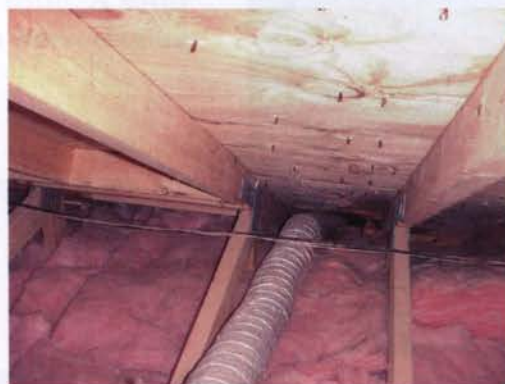
Bathroom/Kitchen: Mold was found on the bathroom ceiling. The fan vented through a plastic ribbed duct. The duct terminated above a soffit vent in the eave (Figure 3). The kitchen exhaust fan vented to the outside.

Figure 3 - Bathroom exhaust fan vented through soffit - some mold is visible on sheathing

- Ensure that bathroom and kitchen exhaust ducts are properly attached and sealed to the exhaust fan housings. All ducts should terminate outside the house and not within the soffit area. Ensure that the ducts terminate and are sealed to a vent designed for exhaust fan soffit termination.

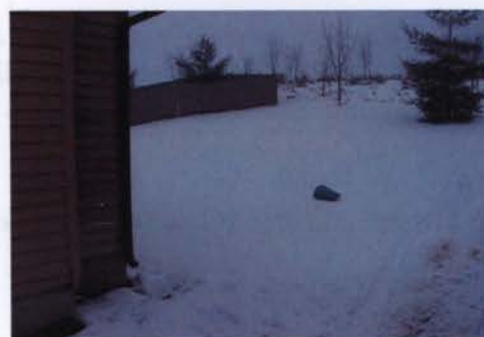
Mold and Moisture Conditions: Site drainage was quite poor. The home was located at the base of a small hill (Figure 2). Localized dips and holes were found adjacent to the foundation. Mold was reported on the bathroom ceiling. The house was vacant and interior remediation efforts were underway.

Figure 2 – Back of home at base of hill

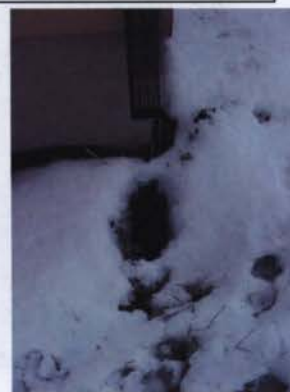
Rainwater Management: A gutter system was present and in good shape. A flip-up leader was broken. Another leader was missing (Figure 3).

Figure 3 – Missing leader

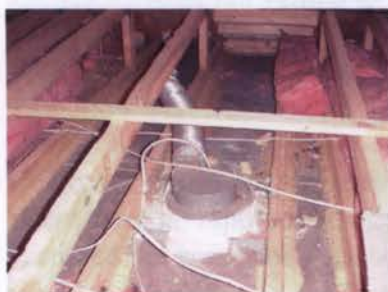
Attic: The attic was insulated with R38 fiberglass batts. Insulation was not replaced on the bathroom ceiling following work on the exhaust fan (Figure 4). Voids and gaps in the attic insulation were visible.

Figure 4 – Missing insulation

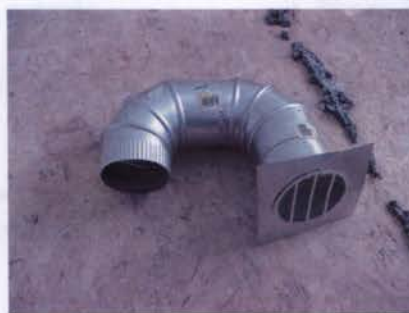
Bathroom/Kitchen: Mold was reported on the bathroom ceiling. The fan was vented through the soffit. A soffit vent termination piece was part of the remediation work. (Figure 5). The kitchen exhaust fan vented to the outside.

Figure 5 – Soffit vent termination piece

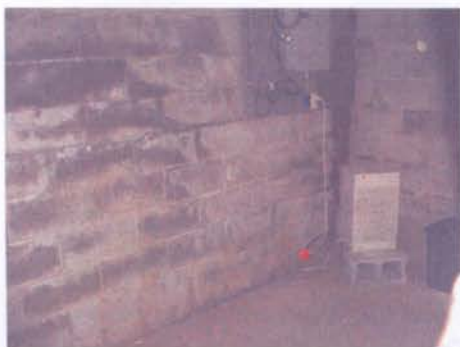
Mold and Moisture Conditions: Site drainage was flat, especially under the rear deck. Gutter system was in good condition. Basement walls were reinforced because of buckling. Basement walls were wet (Figures 2 & 3) and standing water was found on the basement floor.

Figure 2 – Wet basement walls

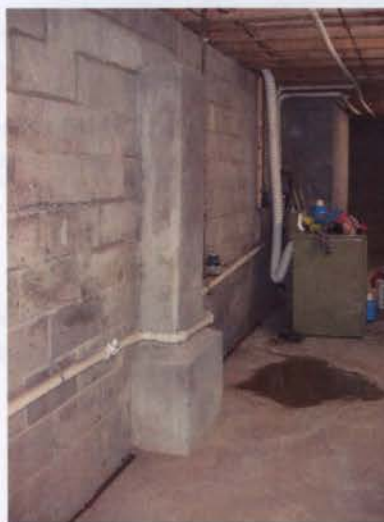
Figure 3– Reinforcing pier

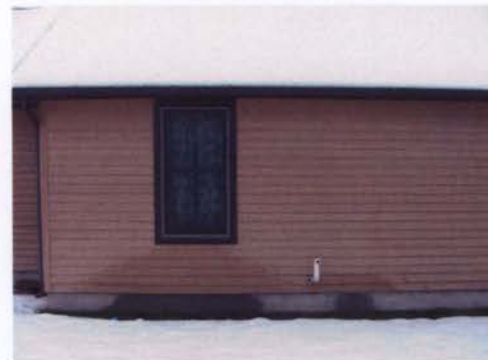
Mold and Moisture Conditions: Site drainage was flat. The rear gutters were full of snow. Water dripping from the gutters was splashing on the siding (Figure 2). Some leaders were missing. Mold was visible on the basement walls (Figure 3). The house had an attached crawl space open to the basement. A ground cover was present, the duct was insulated, foundation walls were not insulated and the vents were sealed. There was a fair amount of clutter in the crawl space.

**Figure 2- Back splash against siding from gutter snow melt**

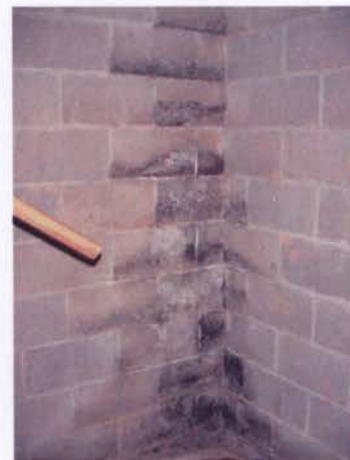
**Figure 3 – Mold on basement wall**
